# The REMR Bulletin

Volume 9, Number 1

March 1992

# Spillway Remediation at Saylorville Lake

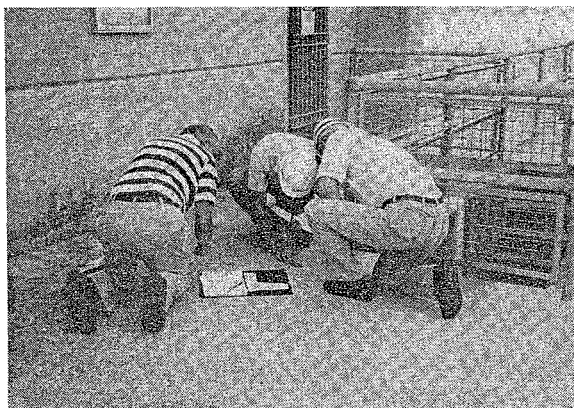
**Figure 2. Inspectors measuring the width of a crack in a concrete lockwall monolith.**

The concrete lockwall inspection entails both walking and boat tours at high and low pool. Crack widths, location, and orientation are recorded. Losses of volume because of deterioration are measured. The extent of spalled joints, leaks, and damaged or missing armor is noted.

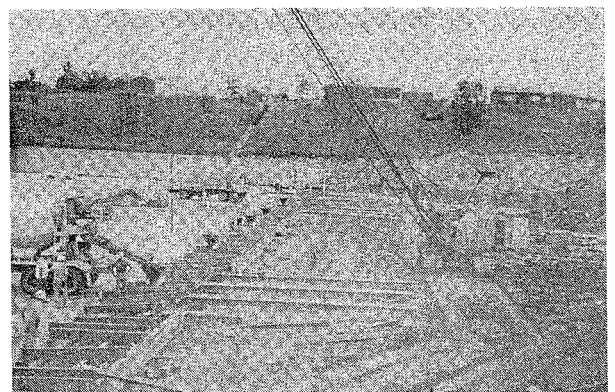
A critical line of defense to ensure that headcutting did not undermine the spillway was the installation of a concrete cutoff wall immediately downstream of the concrete apron (Figure 2). The

Figure 2. Installation of concrete cutoff wall.

wall is approximately 470 ft long, 35 ft high, and 3.5 ft thick. It is keyed into a dense siltstone layer. The cutoff trench was installed by presplitting the rock strata prior to excavation (Figure 3) and placing reinforcing steel mats in each face of the cutoff wall. The cutoff wall construction consisted of one monolithic concrete placement of approximately 1,750 cu yd of concrete.

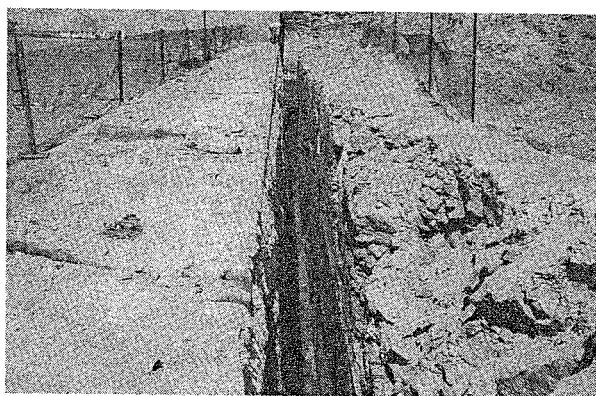
**Figure 3. Excavated trench for installation of concrete cutoff wall.**

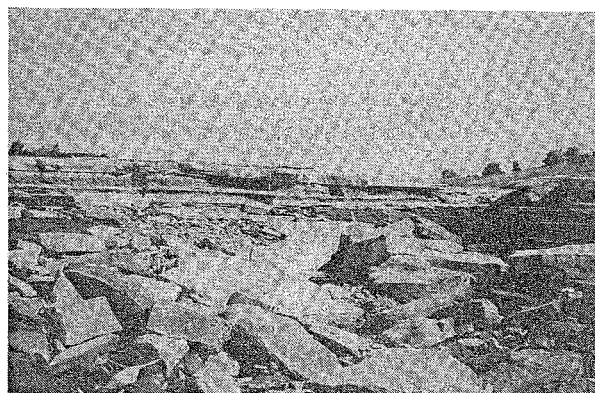
sistant beds was lost to undercutting. Large pieces of caprock that had been previously jointed but in place were displaced as they migrated downslope on the soft underlying shale (Figure 4). However, the caprock sandstone lost very little new material, and that which was lost was jointed and had been left uncovered. When the water receded, several of the rock units had advanced their headcutting upstream by a substantial amount, but there was little additional lateral erosion on any of the units.

**Figure 4. Blocks of caprock sandstone displaced in 1991 overflow event.**

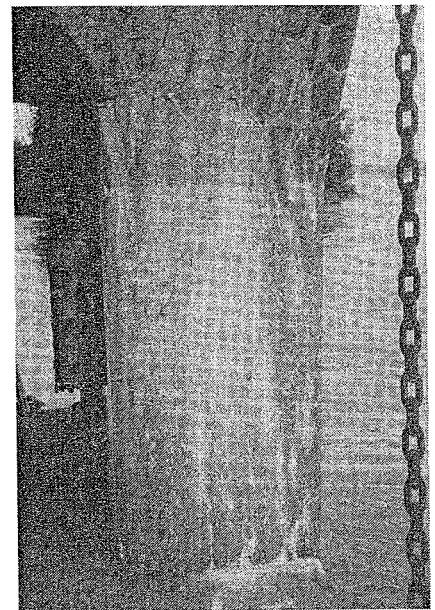
During the more-than-50 years of the structure's existence, severe climatic conditions, coupled with initiation of cracks and poor drainage at the top of piers, had contributed to the deterioration of the non-air-entrained concrete. It is believed the cracks were initiated by the inability of the expansion slots in the bridge girders to move freely with temperature variations. Broken bearing bolts found during periodic inspections of the dam support this hypothesis.

Additionally, the bridge bearings were recessed on many of the piers, resulting in poor drainage that allowed water to pond on top of the piers. This water then percolated down through the cracks into the pier stem. Cores taken from the structure at various times through the last 10 years were subjected to petrographic examination by the Missouri River Division Laboratory; these tests revealed the cause of the concrete deterioration to be from reaction to cyclic freezing and thawing and to alkali aggregate.

Figure 1. Upstream face of Pier 42 as seen during the concrete condition survey performed in 1985.

This survey recommended the removal and replacement of 15 of the 42 bridge pier stems. These severely deteriorated piers were 19 through 26, 31, 32, and 38 through 42 (Figures 1 and 2). The recommendation for the other 21 less deteriorated pier stems was to selectively remove portions of the piers and then replace these with conventional air-entrained concrete as well as improve the drainage of all the pier tops.

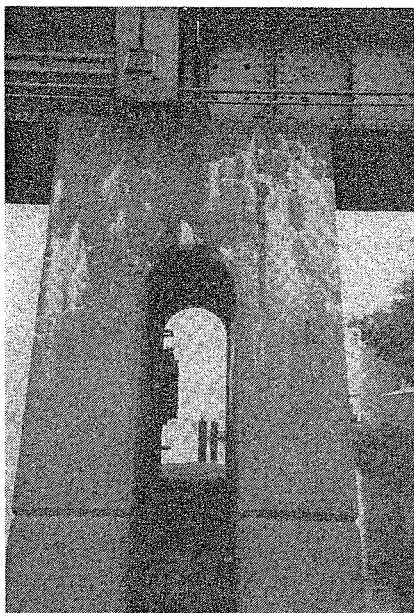
**Figure 2. Downstream face of Pier 42 as seen during the concrete condition survey performed in 1985.**

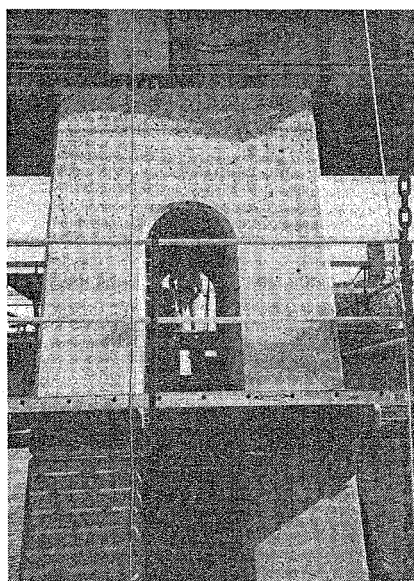
**Figure 3. Downstream face of pier 42 with injection ports being located and installed. A total of 1,052 injection ports were used in Pier 42.**

Cores from Pier 42 (more cracking) averaged 89 percent of the fractures filled in the upper zone (low of 83 percent and high of 94 percent). Pier 42 was injected using 1,052 ports (approximately 1

The first step in the epoxy injection procedure was to clean the surface of the pier with a power grinder. Holes for ports were drilled using a vacuum-attached swivel drill chuck, and ports were installed along the crack network (Figure 3). A water pressure test was then accomplished, and additional ports were set, based on the results. Water pressure tests were limited to a maximum of 40 pounds per square inch (psi).

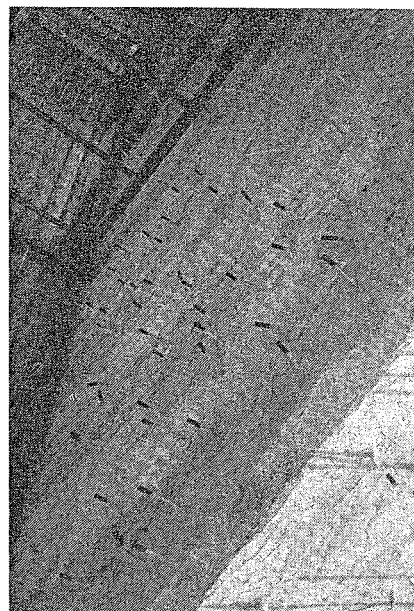
**Figure 4. Typical arrangement of injection ports and epoxy gel surface seal on the side of the piers.**

The surface was sealed with an epoxy gel (Sikadur 32) (Figure 4). Denepox 40, an ultra low-viscosity, two-component 100-percent solids epoxy resin insensitive to the presence of water, was injected through the ports into the pier. Injection started at the lowest point of the area on the pier and moved up (Figure 5). Injection pressures were limited in the specifications to a maximum of 160 psi.

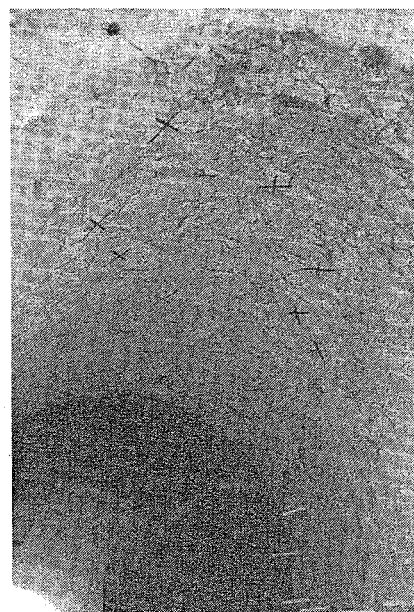
**Figure 5. Locating injection ports (denoted by an x) in the archway of the pier.**
